LITTLE SWAN LAKE - DAM INSPECTION REPORT

June, 2018

KLINGNER & ASSOCIATES, P.C.

Project No. 18-3036

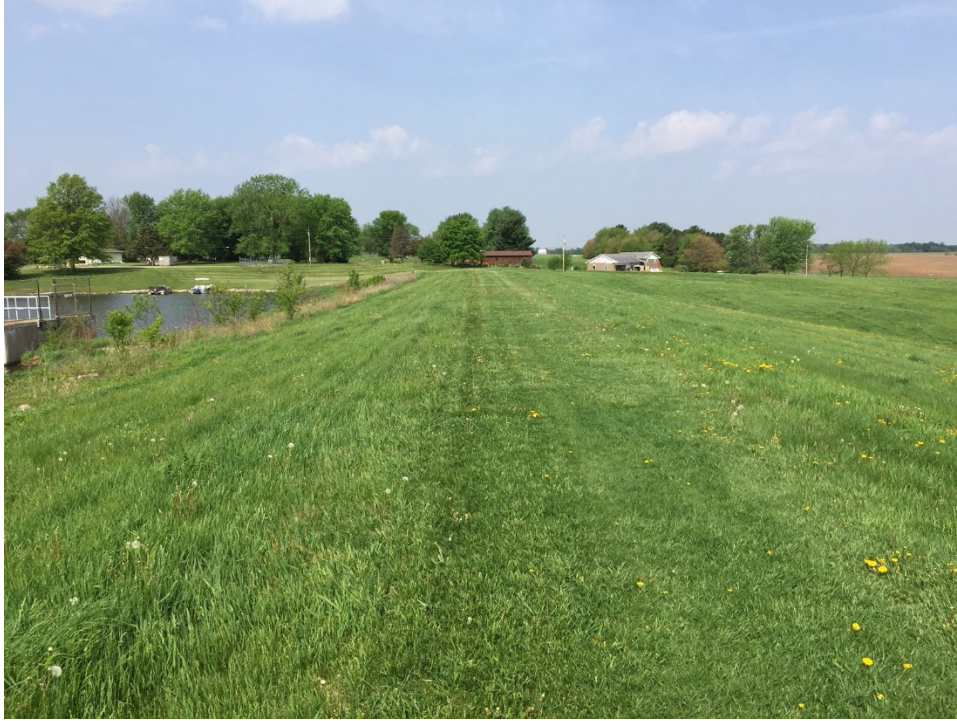
The dam top is approximately 10 feet wide. The dam crest is well maintained and covered with thick, well vegetated, grass. The crest shows no signs of settlement, misalignment, rutting, or cracking. The Crest can be seen in Figure A.1

Description	Dam Crest – Well maintained, no signs of settlement, misalignment, rutting, or cracking.	A.1
Location	40°40'18.76", 90°31'27.29"

No corrective actions on the dam crest are currently recommended. The crest can, and should be kept up using Little Swan Lakes current maintenance/mowing methods and schedule (minimum mowing of twice per year). The crest should be monitored no less than annually for any signs of deteriorating conditions including cracks, sloughs, or depressions.

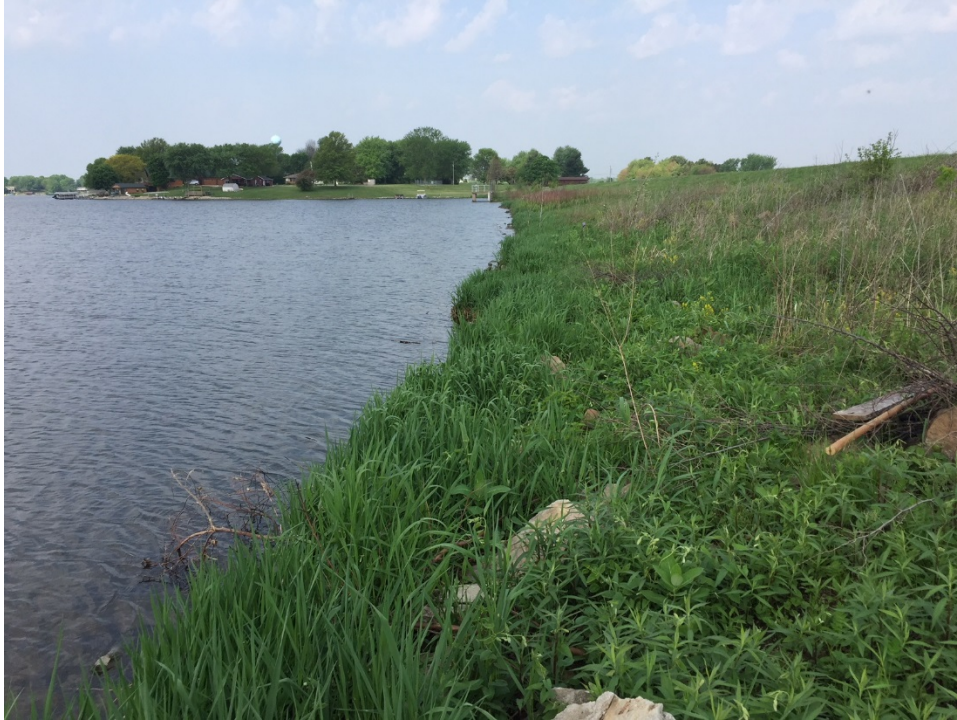
The upstream slope has riprap intermittently lining the upstream face of the dam along its entire length. Rip rap extends approximately 20 feet up the slope (Fig. A.2). The erosion protection and the fact that the dam is oriented in the north-south direction, out of the prevailing wind, has saved the upstream face from erosion, wave wash, and beaching. In general, the upstream slopes are consistent (6H:1V). The upstream rip rap protection is in good general condition and is protecting the upstream slope as designed.

Description	Typical rip rap coverage on upstream slope. Rip rap is heavily vegetated and currently holding the slope well.	A.2
Location	40°40'17.67", 90°31'22.29"

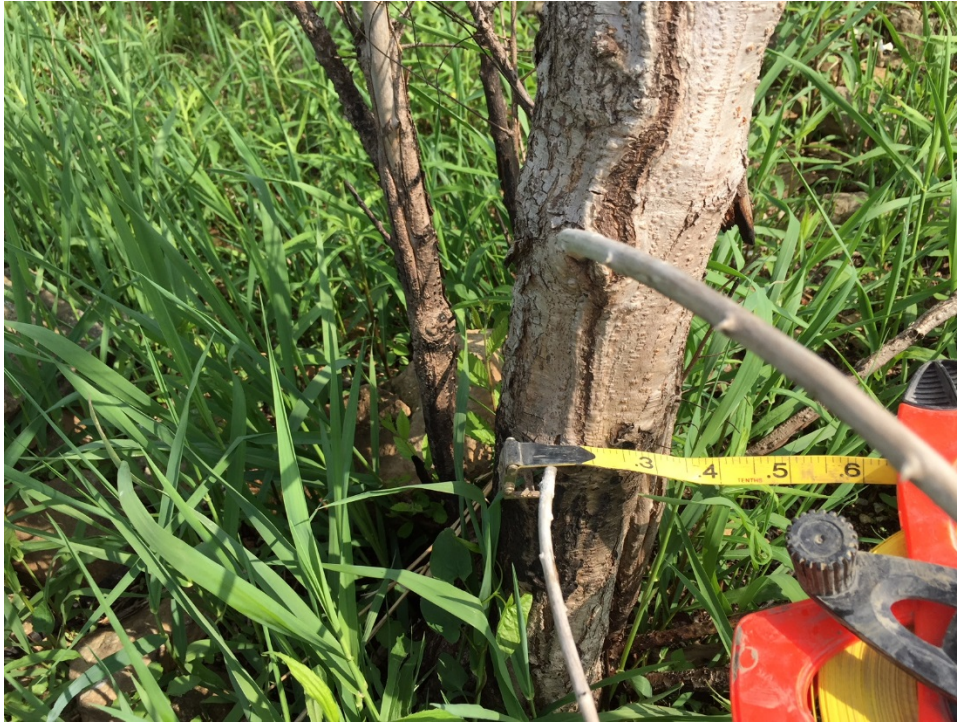
The upstream slope is well vegetated with tall grasses and some woody vegetation up to 4 inches in diameter (Fig A.3). Woody vegetation create large root systems that can create preferential seepage paths through the dam. The root wads can also cause holes in the dam upon their removal and/or upheaval during a storm event.

Description	Woody vegetation on upstream slope. Some trees reached approximately 4" in diameter.	A.3
Location	40°40'18.54", 90°31'30.34"

Trees and woody vegetation should be removed. Stumps can be removed either by pulling or grinding. All woody material should be removed to about 6 inches below the ground surface. The cavity should be filled with well-compacted soil and grass vegetation should be established. If the stumps cannot be removed, they should be cut flush and chemically treated to prevent further growth. Chemical treatment should be done with care in order to avoid an environmental impact to the lake. Some cutting and treating of stumps has occurred (Fig A.6) as part of the dam's regular maintenance, corrective action may include increasing the frequency of this tree/woody vegetation removal.

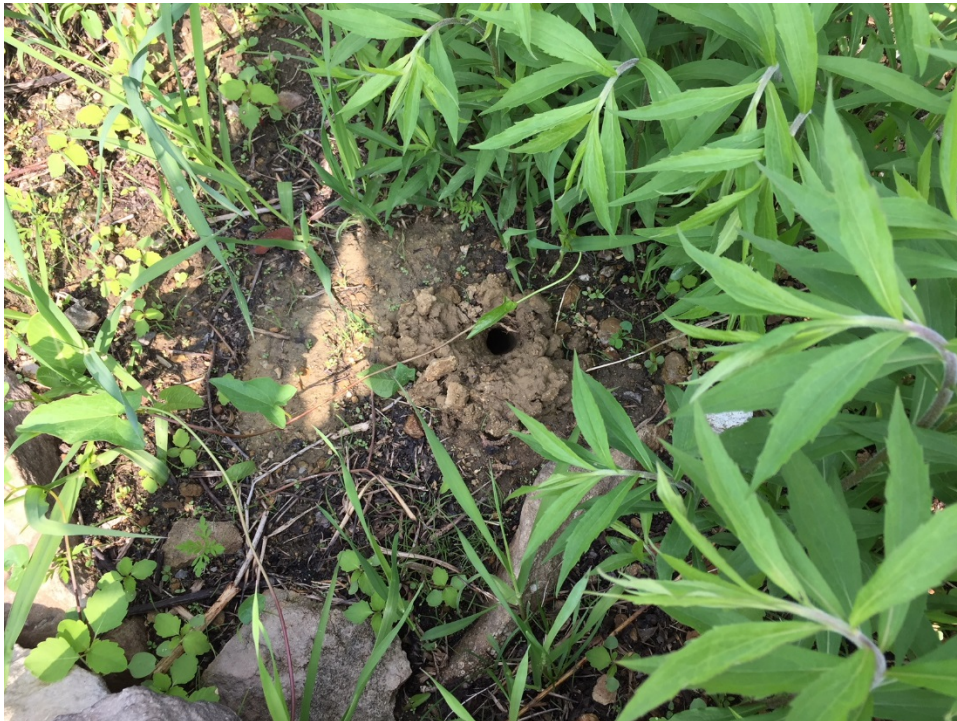
Evidence of burrowing animals were found on the upstream slope. Animal burrows can create flow paths for seep water, and if an extensive network of burrows exists, over a long period of time they can lead to dam failure (Fig. A.4).

Description	Typical animal burrow on the upstream slope of the dam.	A.4
Location	40°40'18.28", 90°31'27.89"

Animal burrows should be eliminated by mud packing or equivalent method. Mud packing is accomplished by placing a vertical pipe over the burrow entrance and pouring a mud pack mixture (such as bentonite). Once full, remove the pipe and tamp the entrance. Vegetation should be established over the burrow hole once it is filled. The rodent population should be controlled near the dam to limit the possibility of future burrowing. Review the current Illinois hunting and trapping laws before taking animal control action.

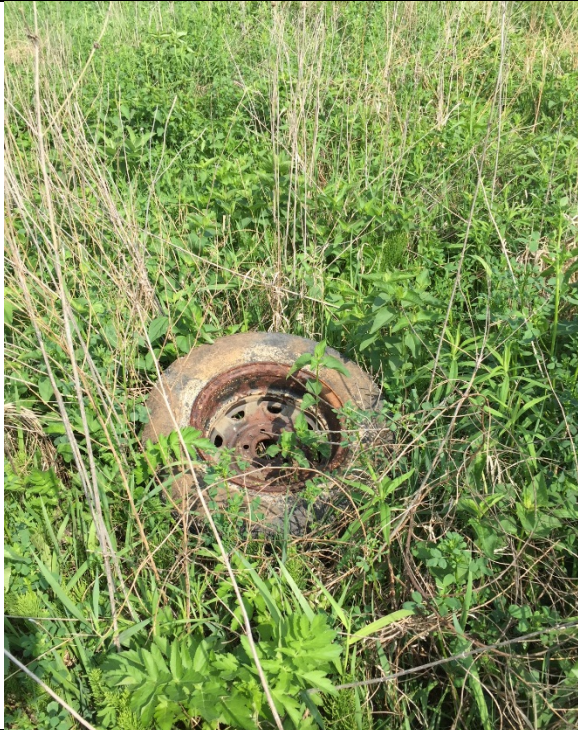
For the most part, trash and debris were not located on upstream slope. The only debris found was a spare tire (Fig A.5). A large accumulation of trash and debris could affect dam performance by damaging spillways or clogging the trash rack. However, the small amount that was observed is not of significant concern.

Description	Debris on upstream slope of dam.	A.5
Location	40°40'18.54", 90°31'33.27"

Trash and debris should be removed from the upstream slope as part of the Lake's regular maintenance program. It is likely that this process is already being completed by the Lake, in which case no action is required.

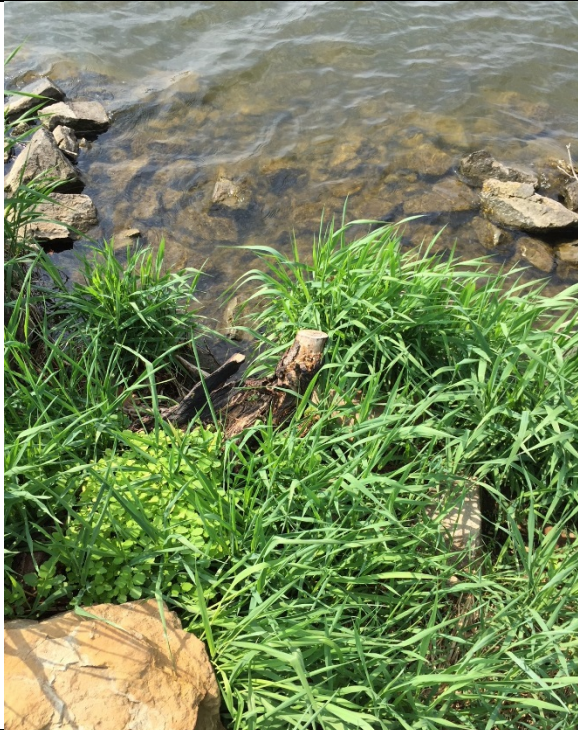
Description	Past maintenance of trees on upstream slope	A.6
Location	40°40'18.65", 90°31'30.53"

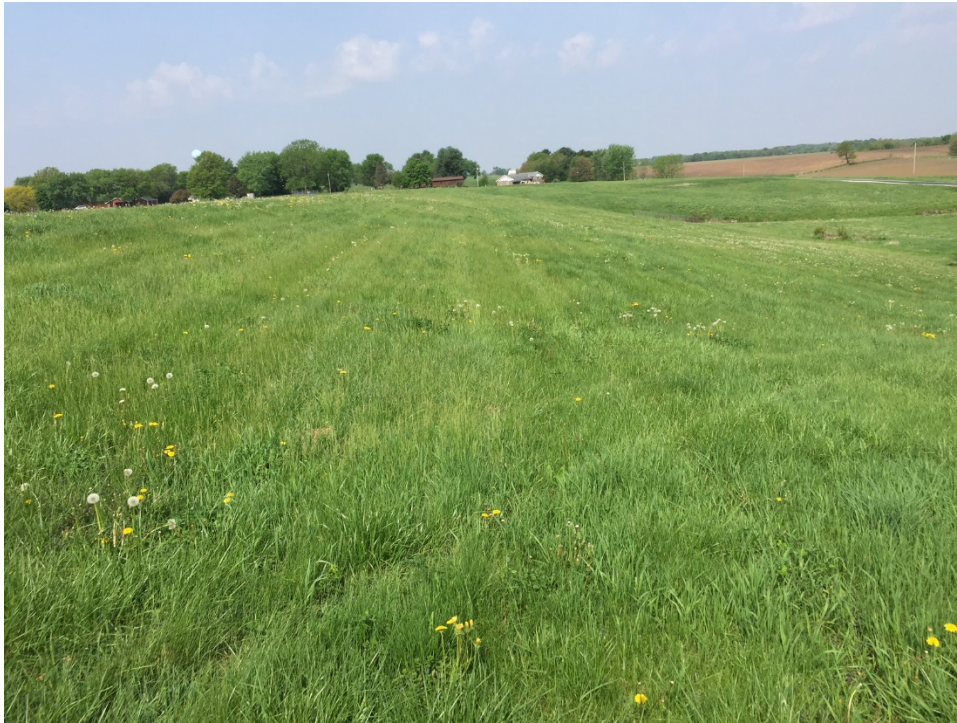
The downstream slope has a strong stand of grassy vegetation and is well mowed and maintained (Fig A.7). No woody or undesirable vegetation was found. The downstream slope is consistent, measured at approximately, 5H:1V. There is a drainage swale south of the emergency spillway at the toe of the dam on the west side. This area was found to have a significant area of soft, wet, spongy soil. In which case the swale is either not draining properly, or there is a seepage issue (Fig A.8). Some animal burrows were also found on the downstream slope, although not as prevalent as on the upstream side (Fig A.9).

Description	Typical view of the downstream slope. Slope is well vegetated and maintained.	A.7
Location	40°40'18.48", 90°31'21.00"

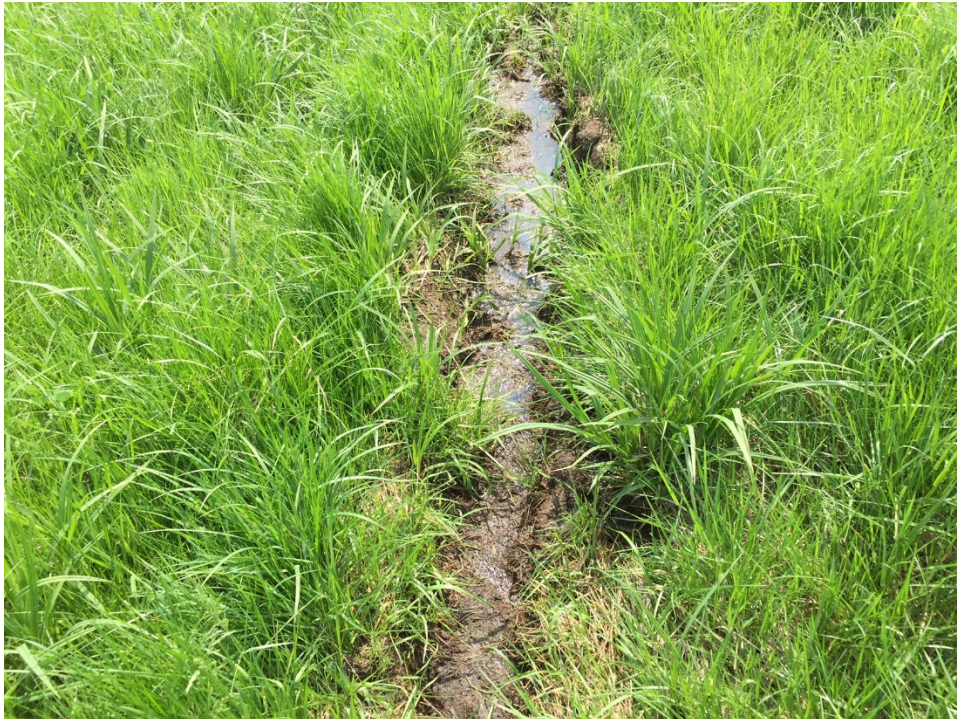
Description	Soft, wet, spongy soils at the toe of the dam on the west side. Likely a sign of seepage.	A.8
Location	40°40'20.58", 90°31'29.73"

Although no plans or design information on the dam or lake were available, it seems that the dam has a pervious blanket and toe drain. The drain is intended to collect seep water from the dam and allow it to drain to the openings on the wing walls in a controlled manner (Fig A.10). These drains should be inspected and if necessary cleaned, repaired, or replaced. It should be noted that the drains were flowing very little water at the time of the inspection, which may be an indicator of plugged drains. If after maintenance to the toe drain, the area remains soft and

spongy, the area worsens, boils appear, or noticeably “dirty” water is seen flowing into this area (i.e. piping) contact IDNR and a licensed professional engineer immediately.

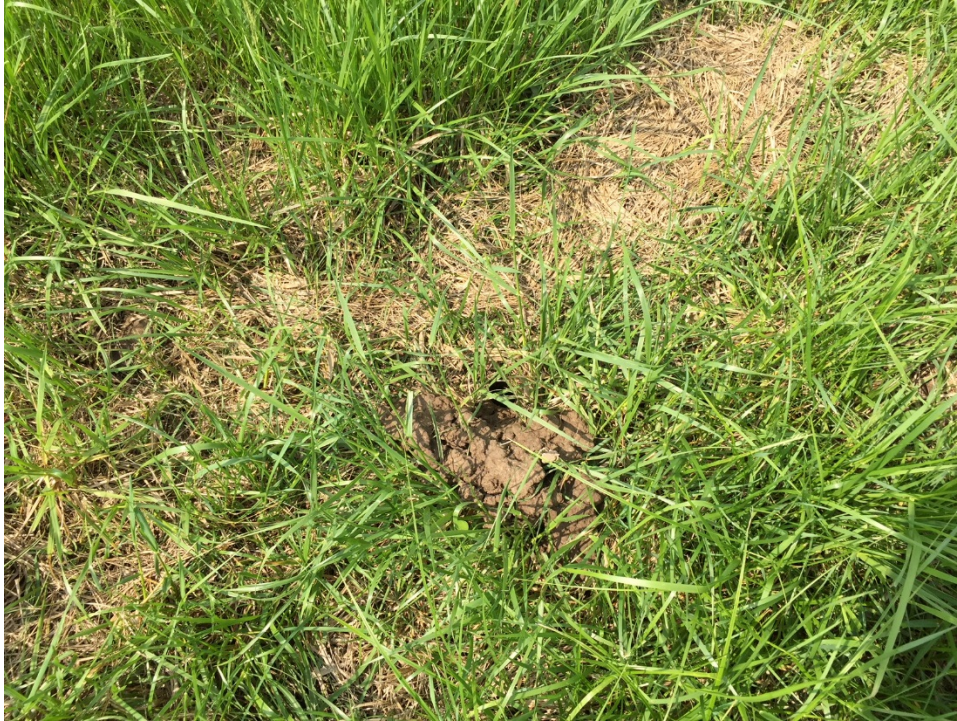
Description	Typical animal burrow on downstream slope.	A.9
Location	40°40'20.55", 90°31'30.06"

As with the upstream slope, animal burrows should be eliminated by mud packing or equivalent method.

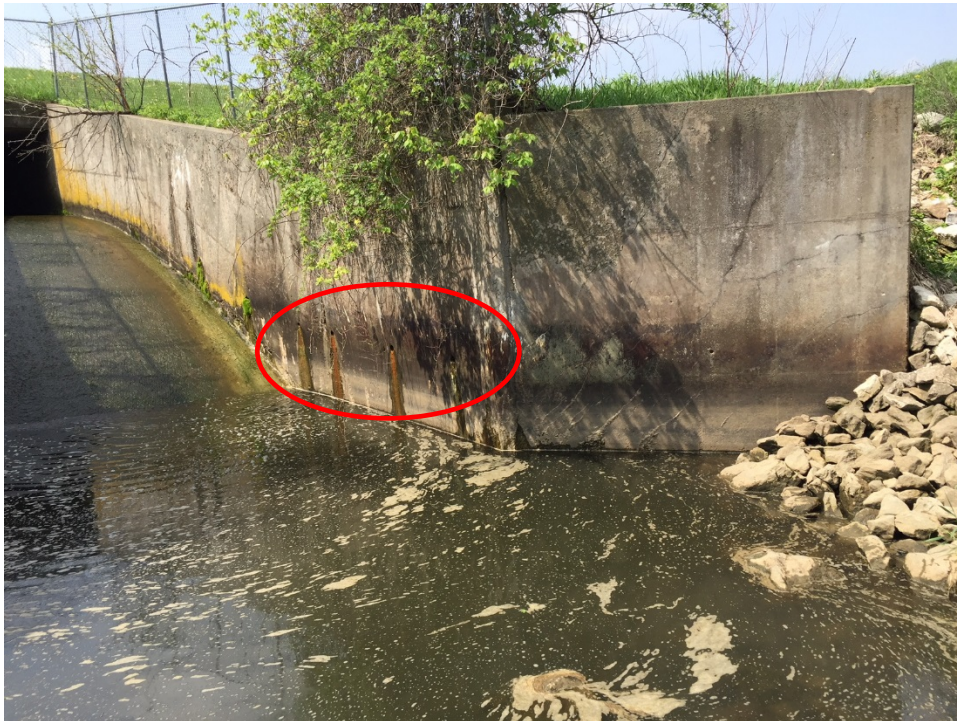
Description	Toe drain outlets, currently flowing very little water. This could be a sign of blocked outlets.	A.10
Location	40°40'21.22", 90°31'28.22"

The seepage collection system and toe drains at the downstream base of the dam should be inspected and flushed then, if necessary, repaired or replaced. The inspection report should be provided to a licensed professional engineering for review. The slide should be filled, well-compacted, and vegetation re-established. If the slide reoccurs or additional slides are observed there may be a significant seepage issue beyond that of the toe drains. If this occurs contact IDNR and a licensed professional engineer immediately.

- a) Toe Drains should be further inspected and flushed, then repaired and replaced, if necessary. The inspection report should be provided to a licensed professional engineer for review prior to any rehab project. Multiple red flags related to seepage/drainage were observed during the inspection including: soft, spongy soils at the dam toe, voids behind the concrete discharge structure, little discharge through the toe drain discharge, and the slide and flowing water discovered near the bridge. No “dirty” water (piping) was observed flowing from these seep areas which means there was no observed movement of dam foundation materials. However, should uncontrolled seepage continue it could easily lead to piping, an extremely dangerous condition which can lead to dam failure. If maintenance to the toe drains do not eliminate seepage concerns, further action will be necessary.

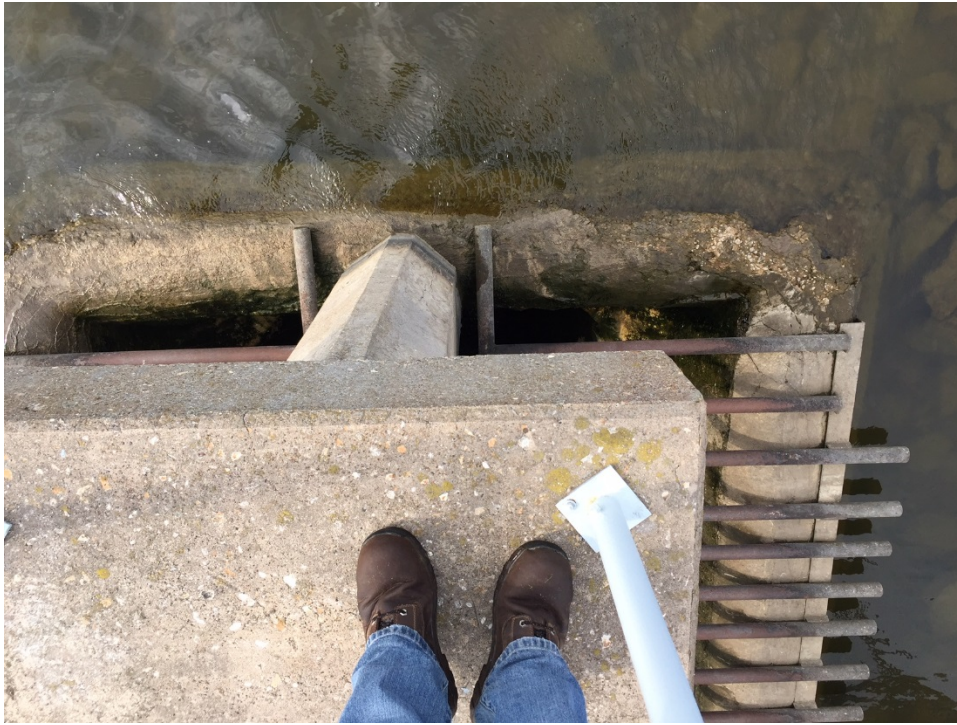
Description	View of concrete drop box. Taken from the top of the gate valve platform.	A.11
Location	40°40'18.21", 90°31'29.40"

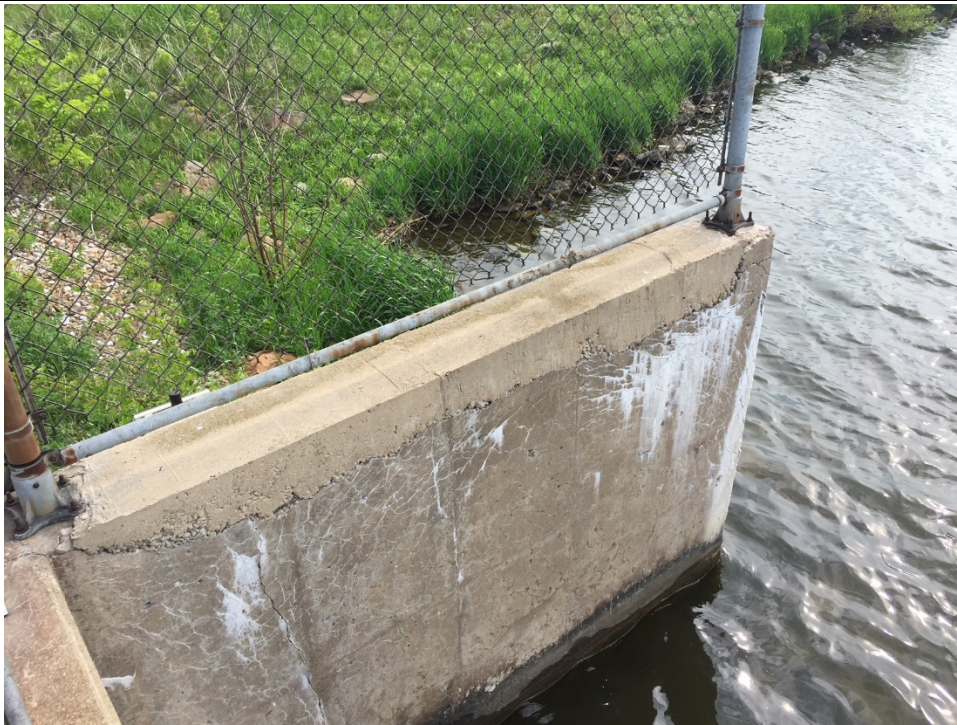
Description	Concrete headwall behind the concrete drop box. Top of wall has recently been repaired.	A.12
Location	40°40'18.27", 90°31'29.29"

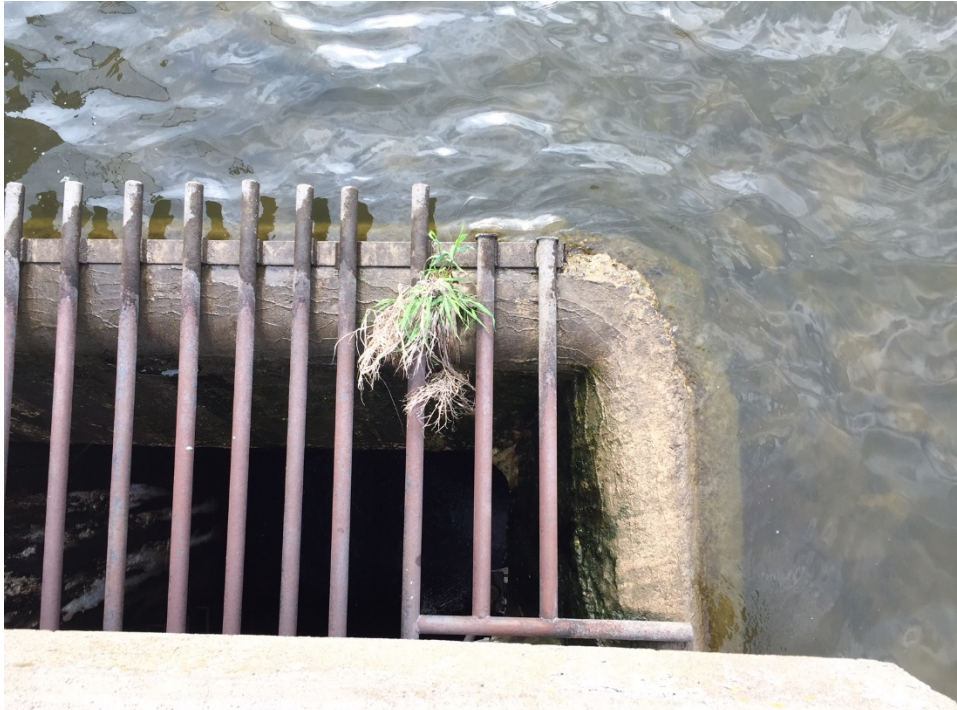
Description	Trash Rack, made up of welded steel poles. Some minor corrosion but poles appear structurally sound.	A.13
Location	40°40'18.20", 90°31'29.35"

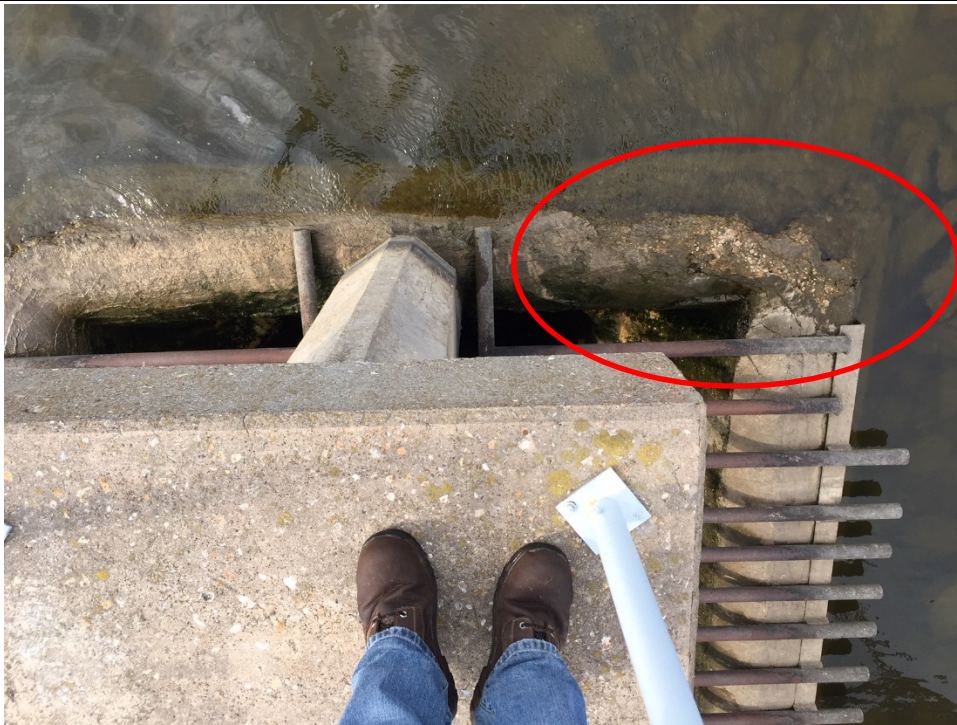
The entrance to the principal spillway drop structure was significantly weathered and deteriorating, scaling, pitting and surface cracks were observed, as well as, major erosion of the inlets upstream face (Fig A.16). At the time of this inspection there was very little water flowing from the lake over the drop box, however the gate valve was partially open therefore allowing some water through the spillway. Only a surface level inspection was performed. Access and lake discharge conditions did not allow safe entrance into the drop structure.

Description	Weathering of the principle spillway entrance.	A.16
Location	40°40'18.21", 90°31'29.40"

The entrance/drop box should be monitored to track the rate of the deteriorating concrete. The Lake may wish to consider setting aside funds for a future rehab project of the drop inlet. The drop shaft should be inspected with equipment/personnel capable of safely accessing the structure.

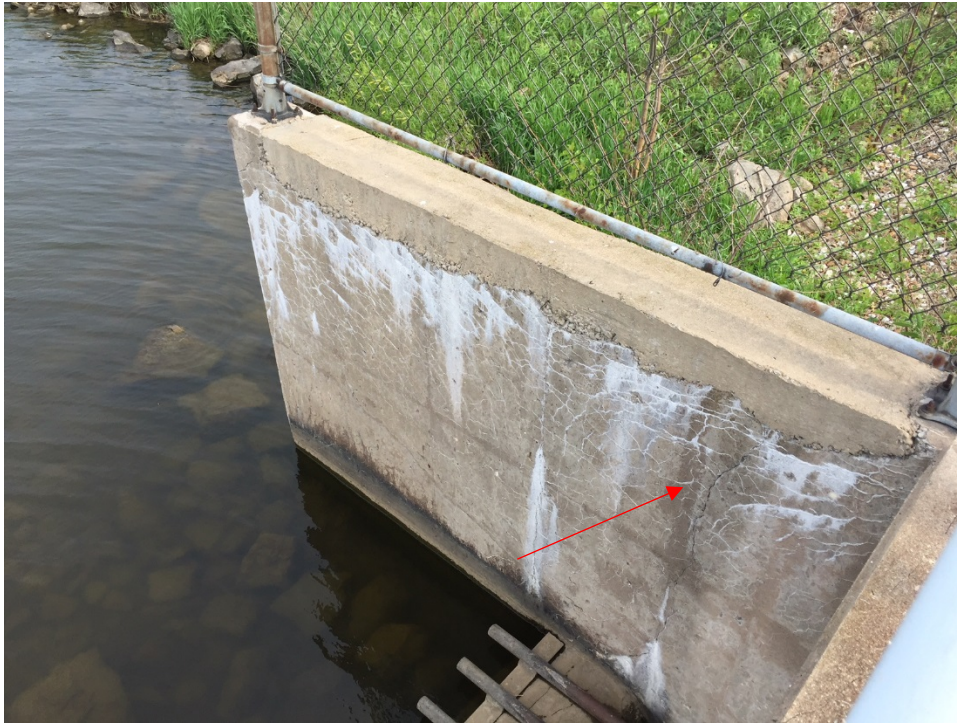
The concrete headwall showed some surface cracks and pitting. However, the top of the wall seems to have been repaired relatively recently and is holding up well (Fig. A.17). There were no signs of exposed rebar or any signs of significant structural deficiencies such as wide structure cracks (greater than 1 in) or misalignment of the wall.

Description	Surface cracks on the concrete headwall.	A.17
Location	40°40'18.27", 90°31'29.29"

Monitor the concrete headwall for structural deficiencies and to ensure surface cracks do not widen.

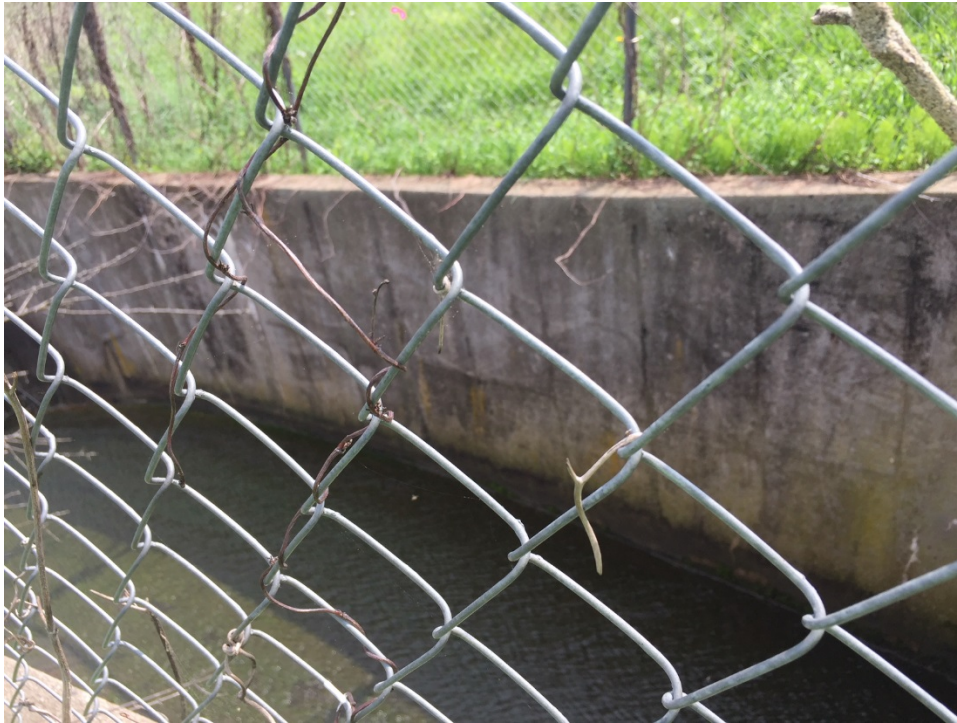
Description	Vertical concrete walls at spillway discharge.	A.18
Location	40°40'20.62", 90°31'28.52"

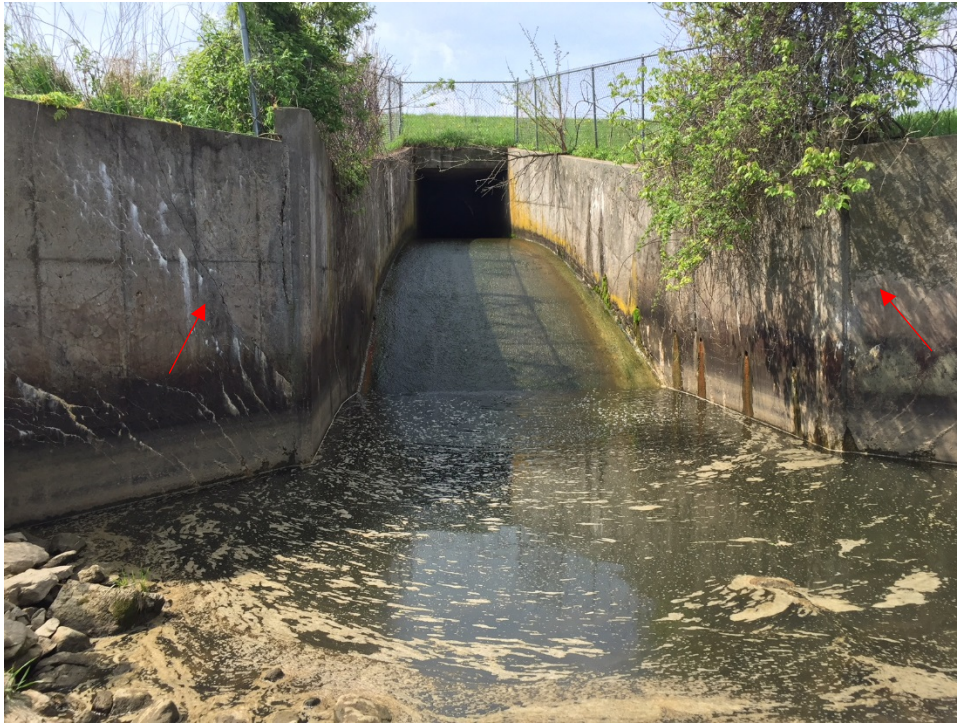
Description	Surface cracks on concrete walls of the discharge structure.	A.19
Location	40°40'21.29", 90°31'28.22"

The spillway discharge should be monitored for structural deficiencies and to ensure cracks do not widen. Woody debris around the concrete walls should be removed to about six (6) inches below the ground surface and the cavity filled in with well-compacted soil and grass vegetation established. If the stumps cannot be removed, they should be cut flush and chemically treated. Care should be taken in the chemical treatment in order to not have an environmental impact on the downstream channel. Voids behind the concrete walls should be filled, compacted, and vegetation established. Voids may be due to improper function of the seepage collection and toe drain. Further inspection and maintenance of the toe drain is recommended. If voids reoccur IDNR or a licenses professional engineer should be consulted.

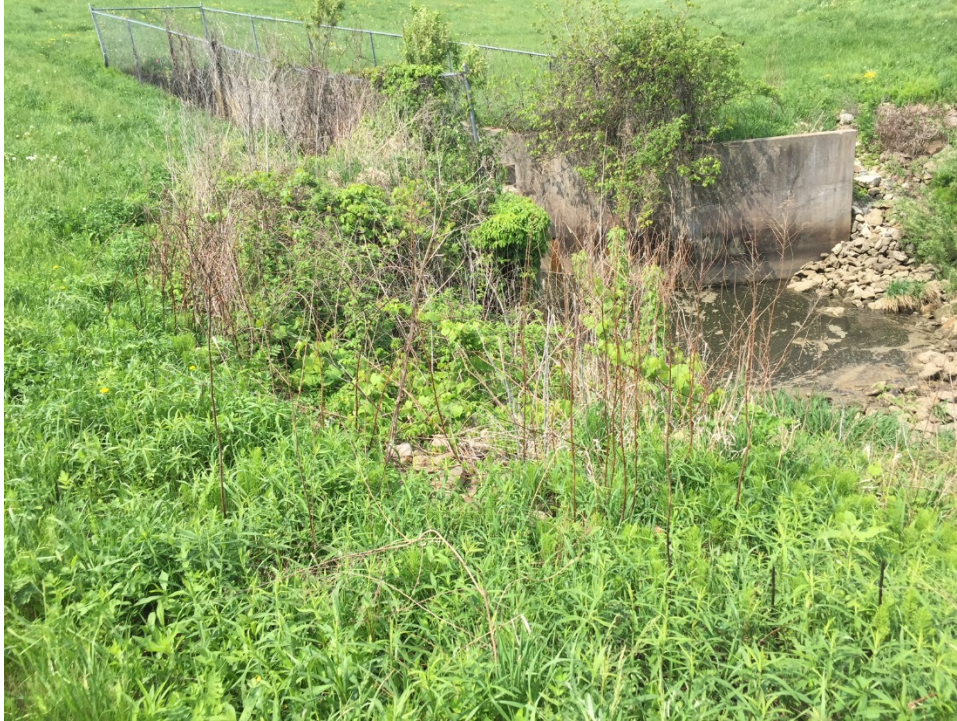
The principal spillway has a formed concrete chute discharge that flows into a rip rapped stilling basin. The chute has vertical concrete walls which then flare into concrete wingwalls (Fig. A.18). The chute and walls show signs of minor deterioration such as surface cracks and pitting (Fig. A.19). No structural concerns were observed such as large structural cracks (greater than 1 in), exposed rebar, misaligned walls, etc. The stilling basin seems to be operating as intended (Fig A. 20). There were no signs of excess scour in the basin or in the downstream channel. Rip rap showed little displacement. There was a significant amount of woody debris that has grown up around the concrete walls and chain link fence (Fig. A. 21) and some depressions were noted behind the concrete walls (Fig. A. 22).

Description	Woody debris surrounding concrete walls around discharge structure.	A.21
Location	40°40'21.17", 90°31'27.45"

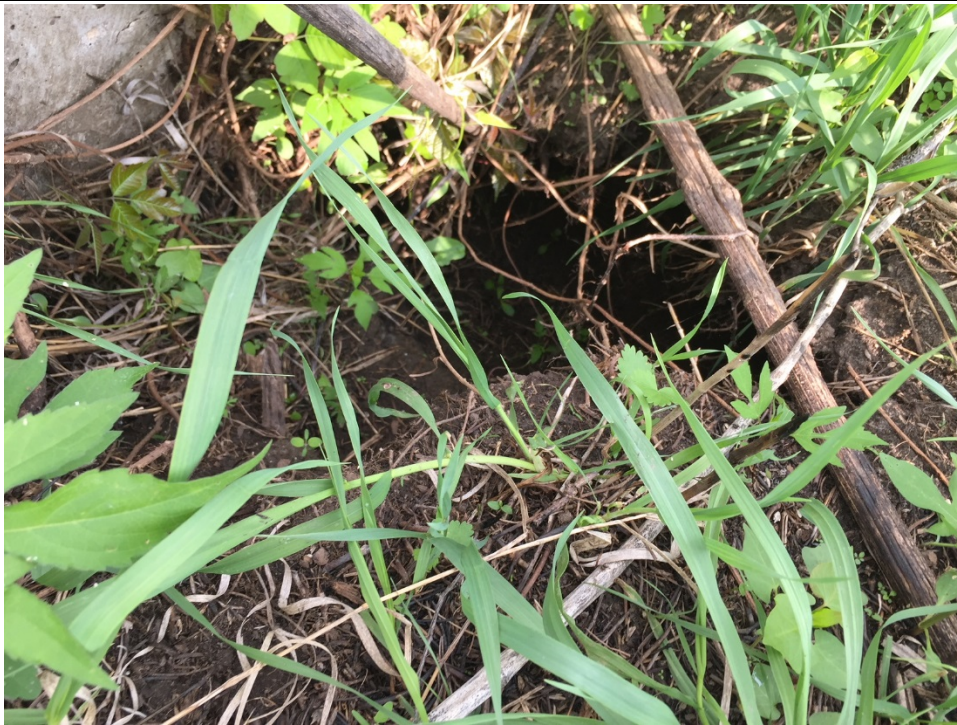
Description	Depression on the east side of the concrete walls surrounding the discharge structure.	A.22
Location	40°40'20.81", 90°31'28.28"

- b) Repair voids and slides possibly caused by the seepage issue by filling, compacting, and vegetating. If voids and slides re-occur contact IDNR and a licensed professional engineer.

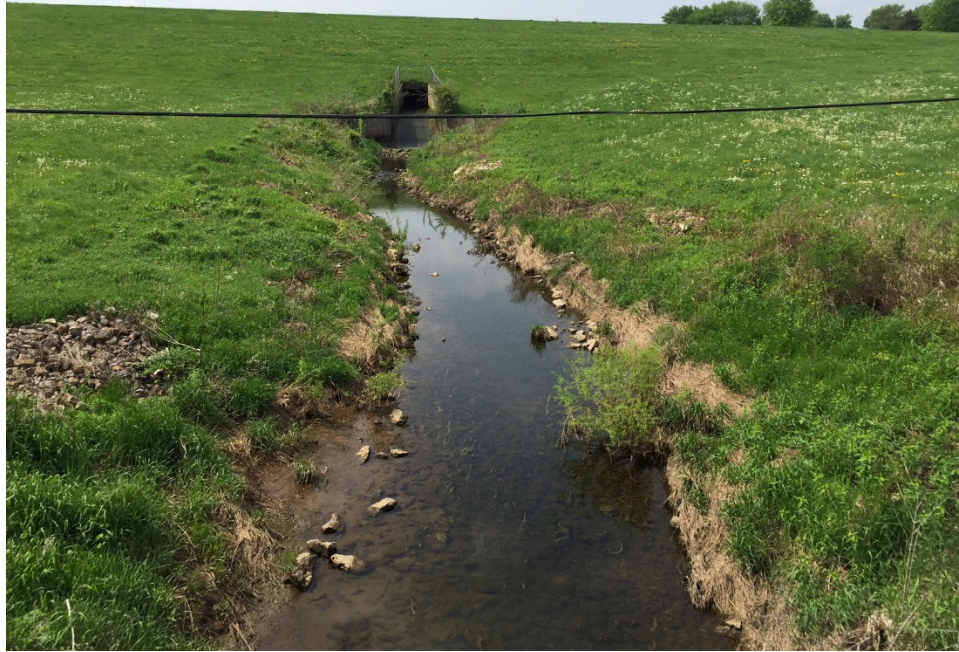
The channel downstream of the principal spillway is approximately 60 feet wide at its top, it is well vegetated and shows little to no signs of erosion (Fig A.23). Based on the condition of the channel it seems that the principal spillway discharge structure does a sufficient job of dissipating energy prior to entering the channel. A slide was noted approximately 30 feet south of the 30th Avenue Bridge and 250 feet north of the dam (Fig A.24). Flowing water could be seen at the bottom of the slide. There is a drainage swale along the road immediately upstream of the slide and it is not clear whether the discharge is due to the saturated conditions of the swale or from the seepage of the dam. If it is seepage from the dam this may be of significant concern and is a sign that the seepage collection system is not operating correctly. Given the other observed seepage indicators, it is likely this is due to dam seepage.

Description	Typical view of the dam discharge channel.	A.23
Location	40°40'23.27", 90°31'27.31"

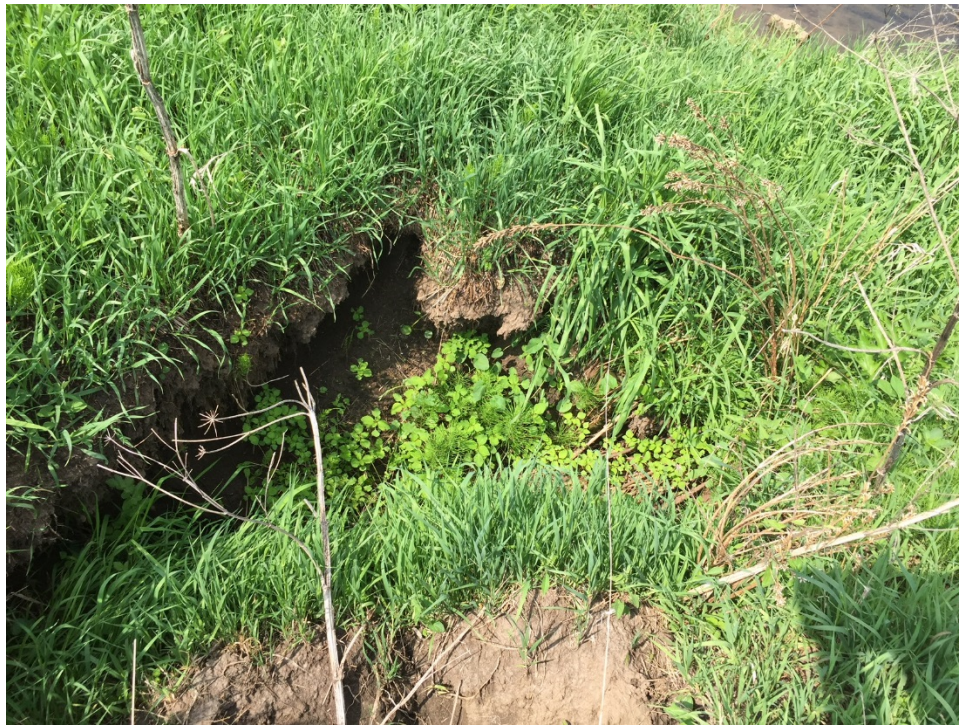
Description	Slide south of the 30 th street bridge. Water flowing from the bottom of the slide was noted.	A.24
Location	40°40'22.98", 90°31'27.09"

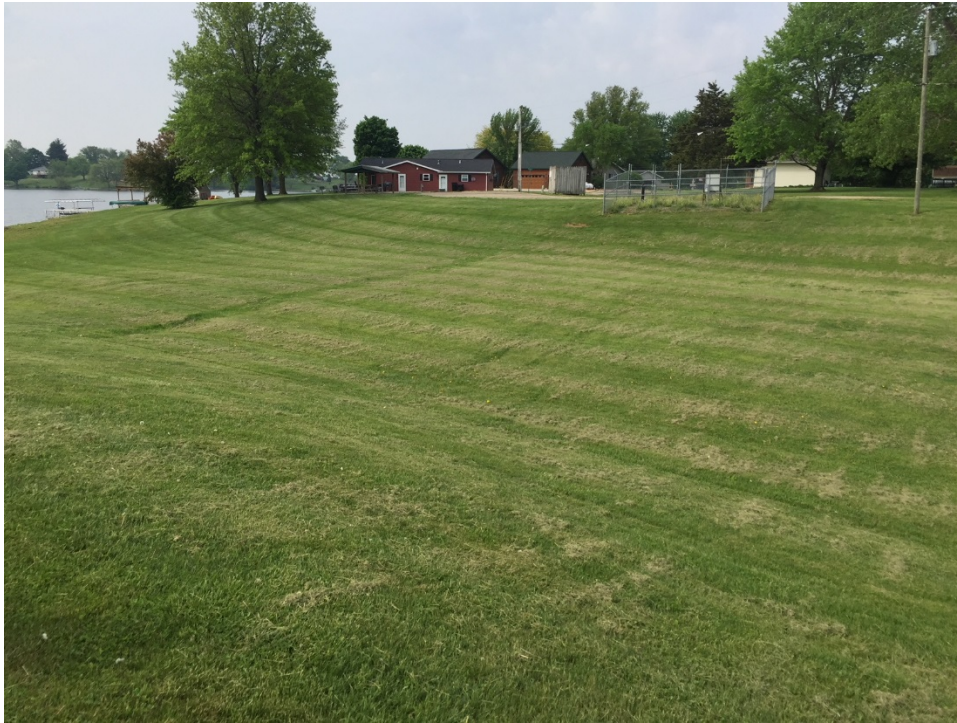
Description	Typical view of the emergency spillway.	A.25
Location	40°40'19.45", 90°31'34.15"

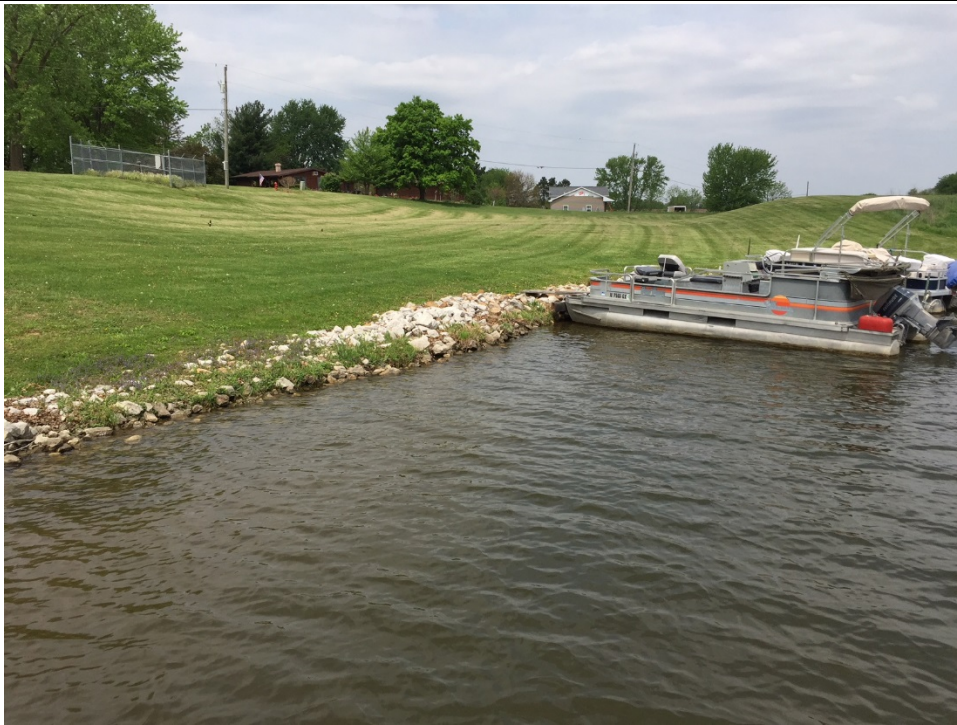
Description	Rip rap lining the entrance to the emergency spillway.	A.26
Location	40°40'17.21", 90°31'33.16"

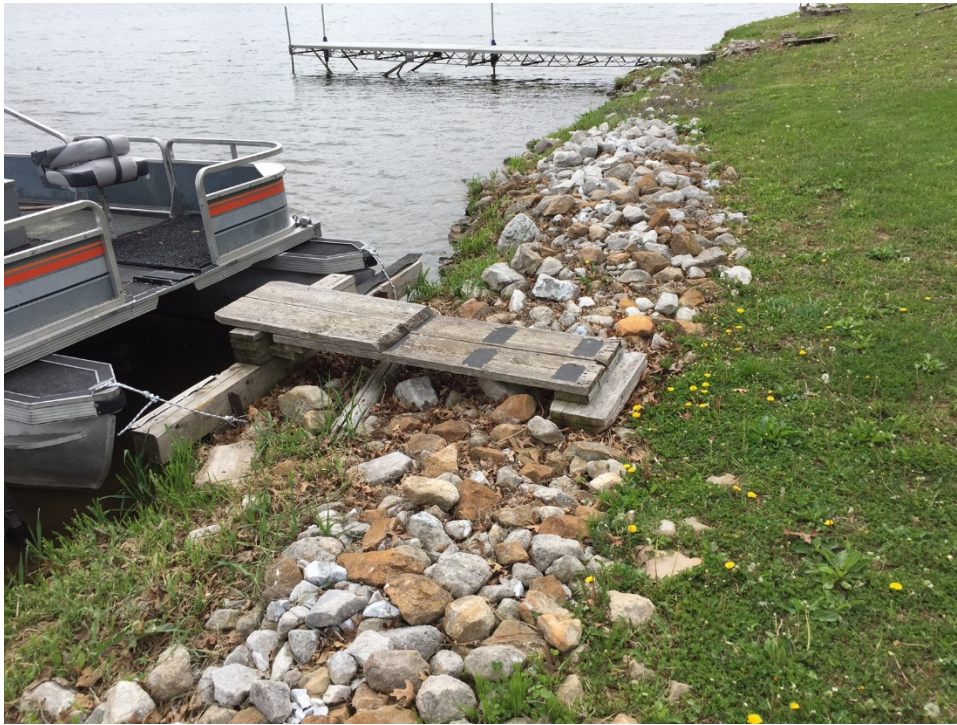
Description	Docks and boats parked within the entrance of the emergency spillway.	A.27
Location	40°40'17.75", 90°31'33.66"

Docks and boats should be removed from the spillway entrance. During a large storm event owners may be unable to remove boats and docks which would lead to them flowing through and blocking or damaging the spillway.

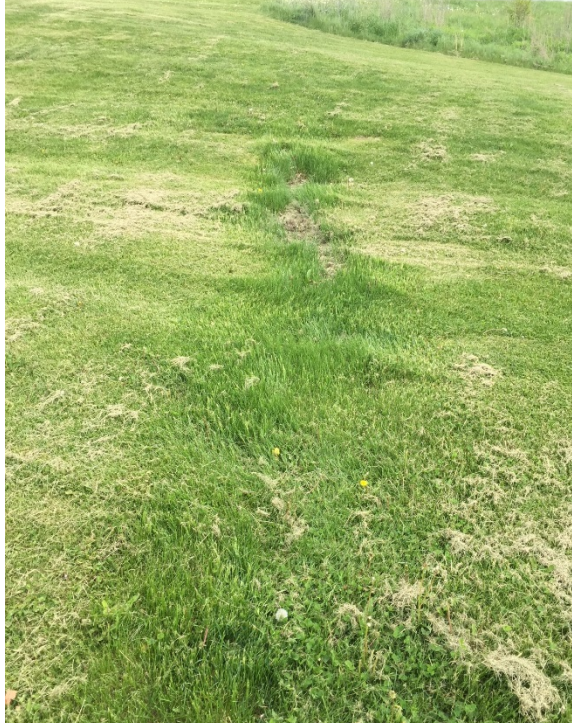
Description	Trench spanning the length of the emergency spillway.	A.28
Location	40°40'18.46", 90°31'34.40"

Unless there is a structural or hydraulic reason for the trench, it should be filled, compacted, and vegetation re-established.

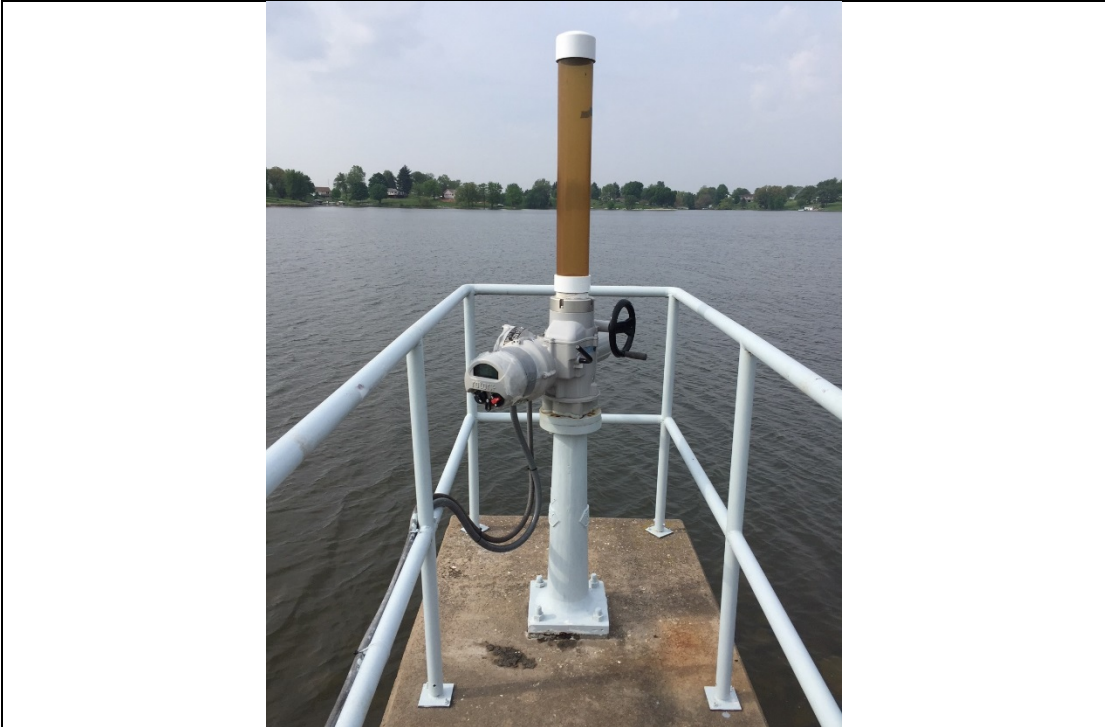
There is a gate valve on the principal spillway used regularly to maintain the lakes desired level and discharge (Fig A.29). The gate and sill could not be inspected due to access and safety issues however, in conversations with Little Swan Lake Representatives and review of the past 2001 inspection report, some issues were uncovered.

The valve is well exercised, the operator stated that it is opened and closed every 2 to 3 months. The mechanism which operates the valve has been recently replaced and can be operated automatically from the Little Swan Lake Club House. According to Little Swan Lake the mechanism works well, and there have been no issues since its installation. The Sluice Gate itself does require some additional inspection and repair/replacement. The gate does not close entirely and has been noted to have issues since at least 2001. To date the Lake has been able to operate relatively efficiently with the broken gate, however if complete failure were to occur it could be detrimental to the dam and those living around the Lake.

Description	Gate valve mechanism.	A.29
Location	40°40'18.28", 90°31'29.35"

Along with the principal spillway conduit inspection noted in 4.4.1.3, the sluice gate and sill should be inspected and the inspection report provided to a licensed professional engineering for review. Based on the results of that inspection, the sluice gate/sill should be repaired and/or replaced.
